National Park Service Jefferson National Expansion Memorial Gateway Arch

St. Louis, Missouri

Historic Structure Report – Volume 1

June 2010

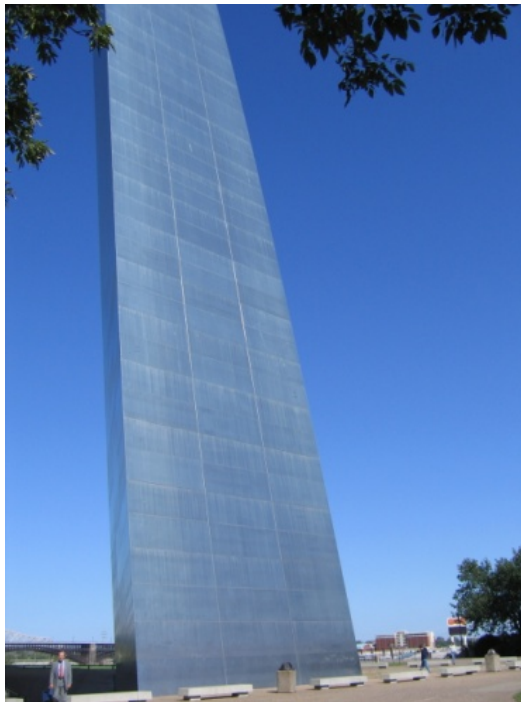
Figure 33. Staining, deposits, and corrosion on south face of south leg due to rain run-off at field welds. Source: WJE, 2008.

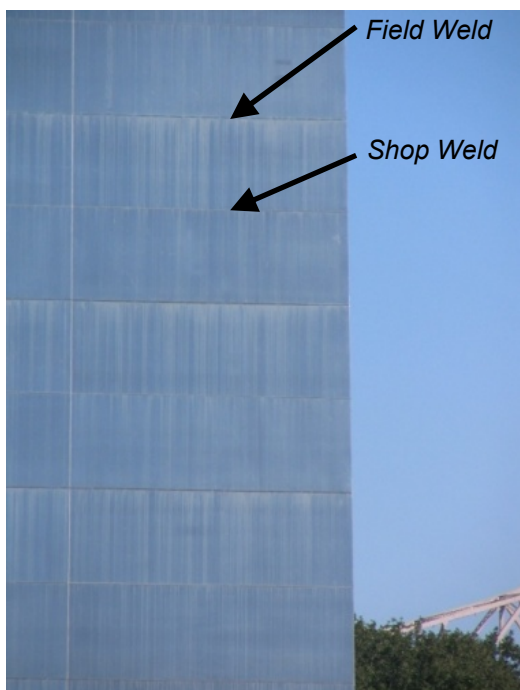
Figure 34. Closer view showing run-off at field welds. Source: WJE, 2008.

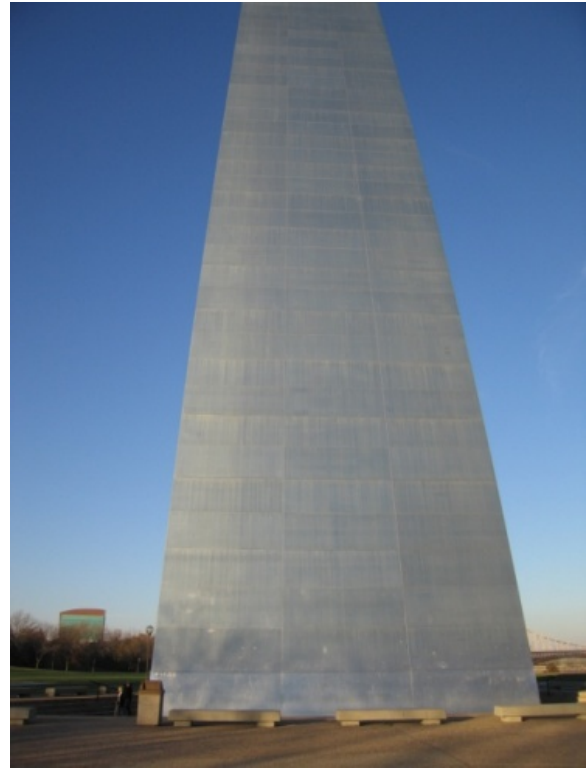
Figure 42. Overview of the south face of the south leg showing streaking originating at field welds. Source: WJE, 2008.

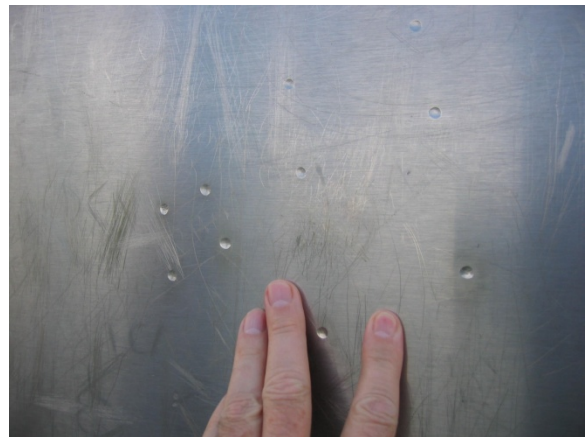
Figure 47. Mechanical damage, likely due to vandalism, at the base of the Arch. Source: WJE, 2008.

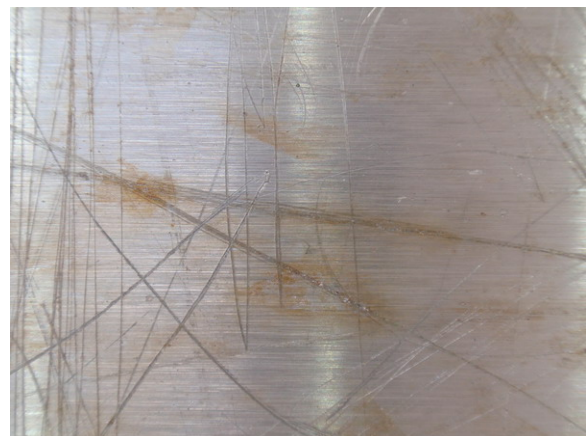
Figure 53. Light red-colored staining at scratches near grade. Source: WJE, 2008.

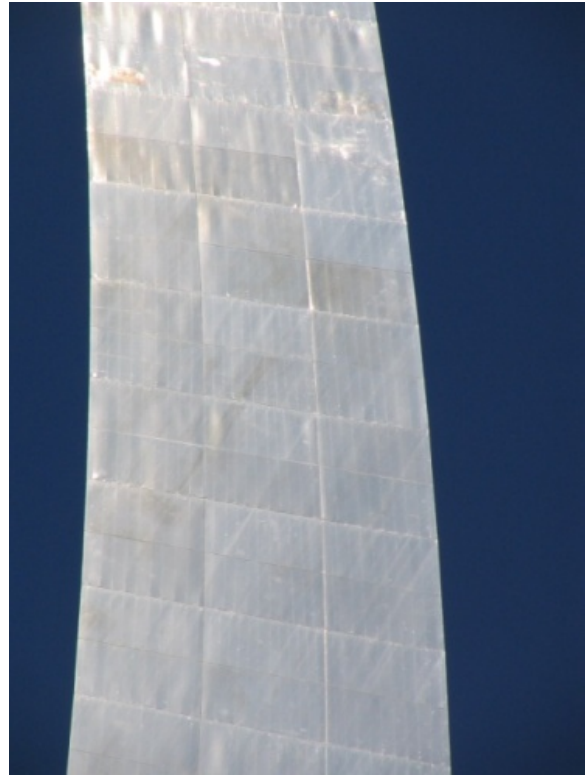
Figure 54. View of oil canning of steel panels on the east face of the north leg. Source: WJE, 2008.

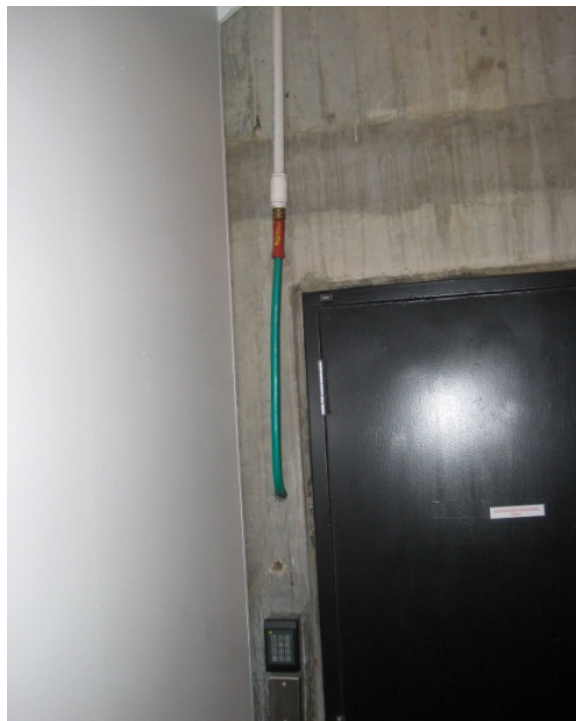
Figure 70. Water collection device installed as temporary repair. Source: BVH, 2008.

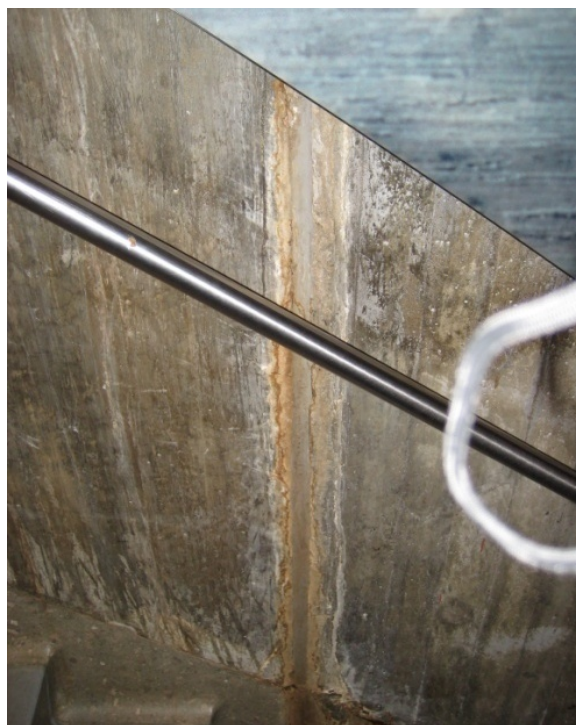
Figure 71. Water leakage at expansion joint in south tram load zone. Source: BVH, 2008.

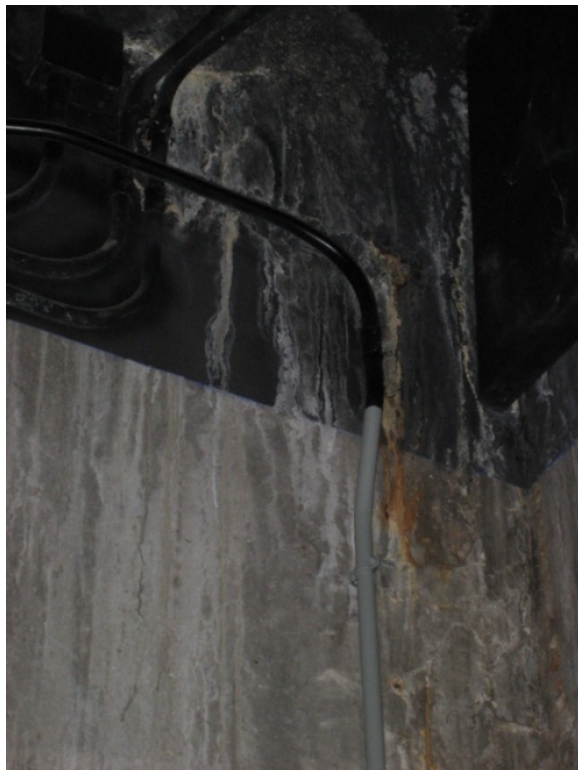
Figure 73. Water infiltration at wall to ceiling junction in north tram load zone. Note accumulation of efflorescence. Source: BVH, 2008.

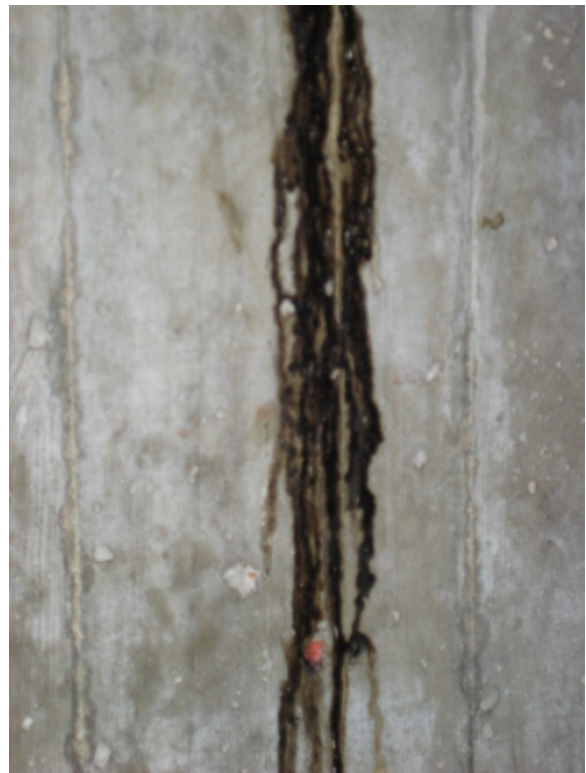
Figure 75. Example of isolated staining on concrete wall in the upper exhibit area of the south tram load zone. Source: BVH, 2008.

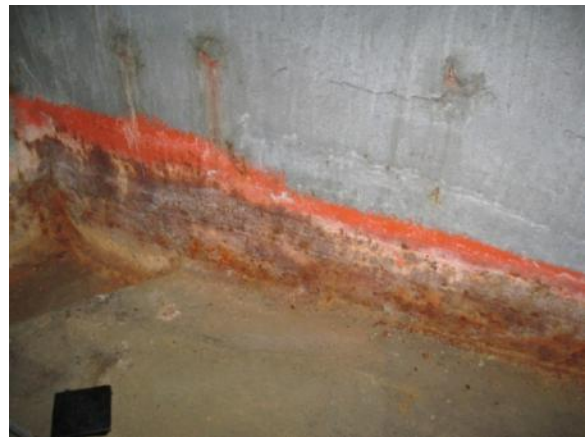
Figure 170. View of corrosion occurring at the base segment in the north leg due to pooling water. Source: WJE, 2008.

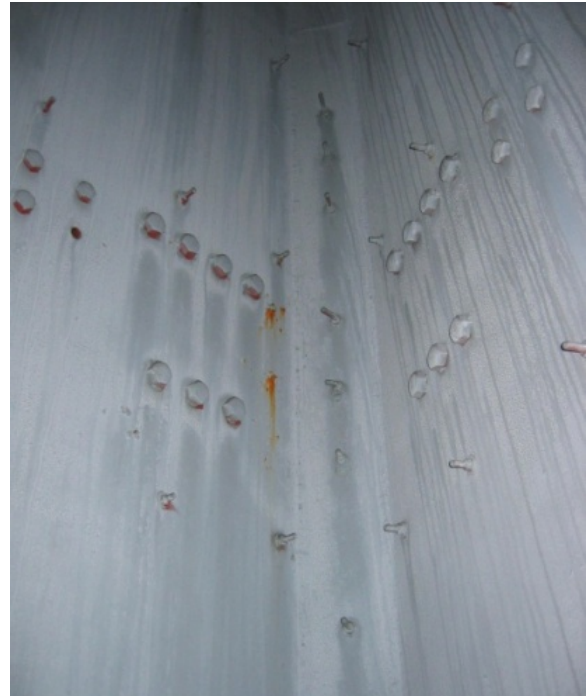
Figure 175. View inside north leg showing corrosion at bolt heads/fasteners in wall. Source: WJE, 2008.

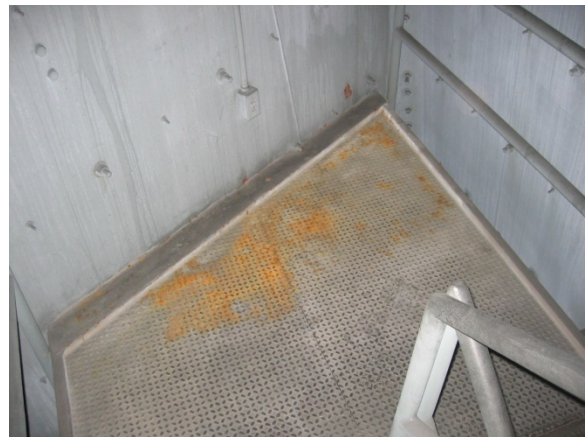
Figure 178. View inside north leg of corrosion at stair landings. Source: WJE, 2008.

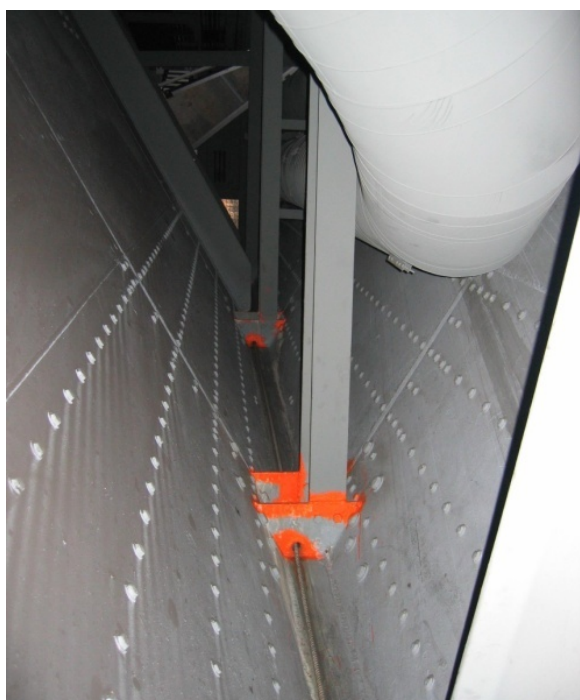
Figure 135. View inside south leg of wick used in water collection system. Note new orange paint coating at locations where corrosion caused distress in original coating. Source: WJE, 2008.

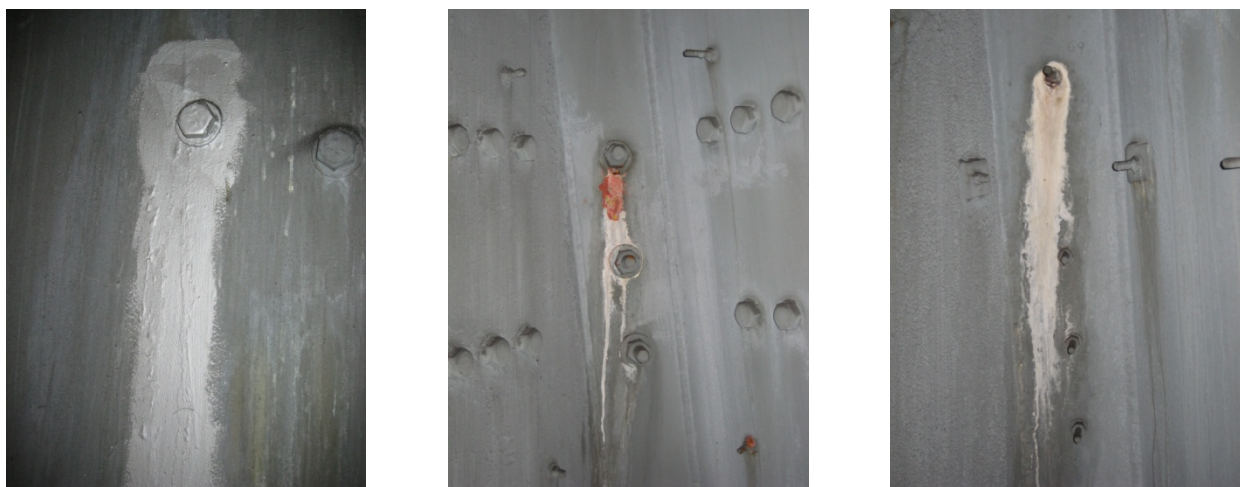
Figure B-7, left. Area of touch-up paint in inner skin in north leg. Note that edges of the adjacent coating were not feathered smooth. Source: WJE, 2008. Figure B-8, center. Area of paint failure exposing primer and corrosion and white deposit (calcium carbonate) below bolt hole at inner skin of north leg. Source: WJE, 2008. Figure B-9, right. Area of calcium carbonate build-up below bolt hole at inner skin of north leg. Source: WJE, 2008.

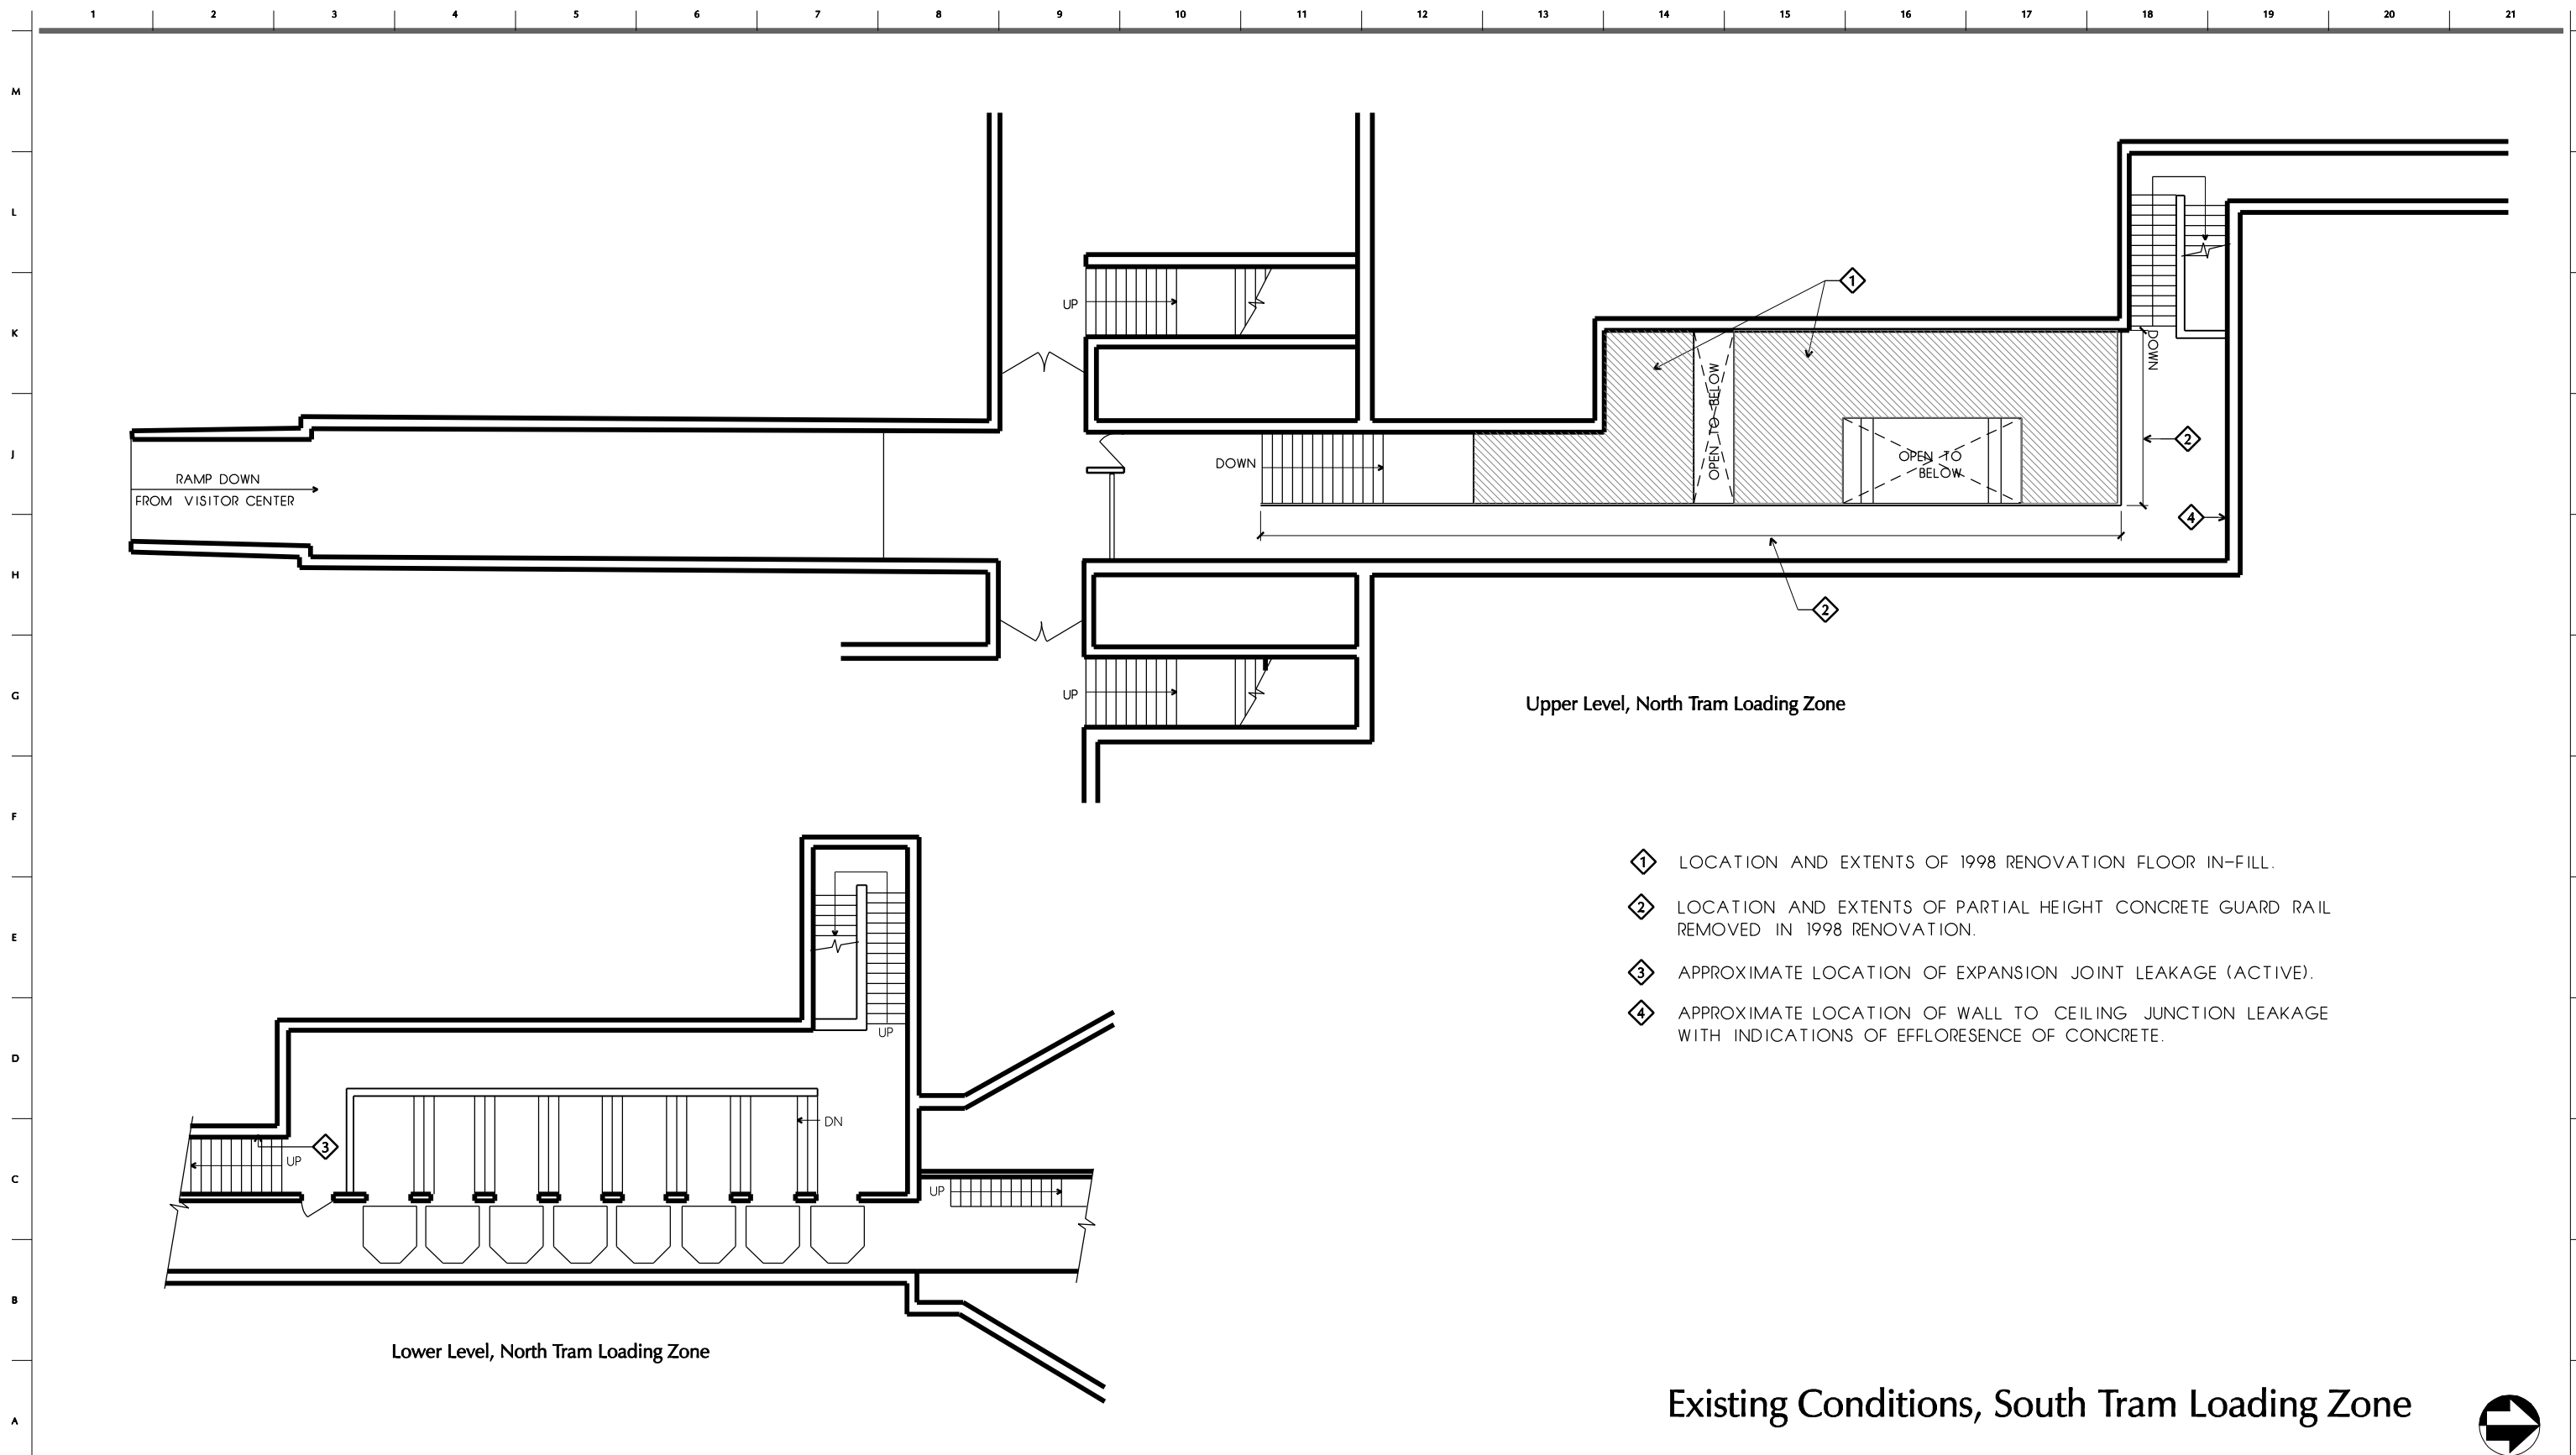
- 1 LOCATION AND EXTENTS OF 1998 RENOVATION FLOOR IN-FILL.
- 2 LOCATION AND EXTENTS OF PARTIAL HEIGHT CONCRETE GUARD RAIL REMOVED IN 1998 RENOVATION.
- 3 APPROXIMATE LOCATION OF EXPANSION JOINT LEAKAGE (ACTIVE).
- 4 APPROXIMATE LOCATION OF WALL TO CEILING JUNCTION LEAKAGE WITH INDICATIONS OF EFFLORESCENCE OF CONCRETE.

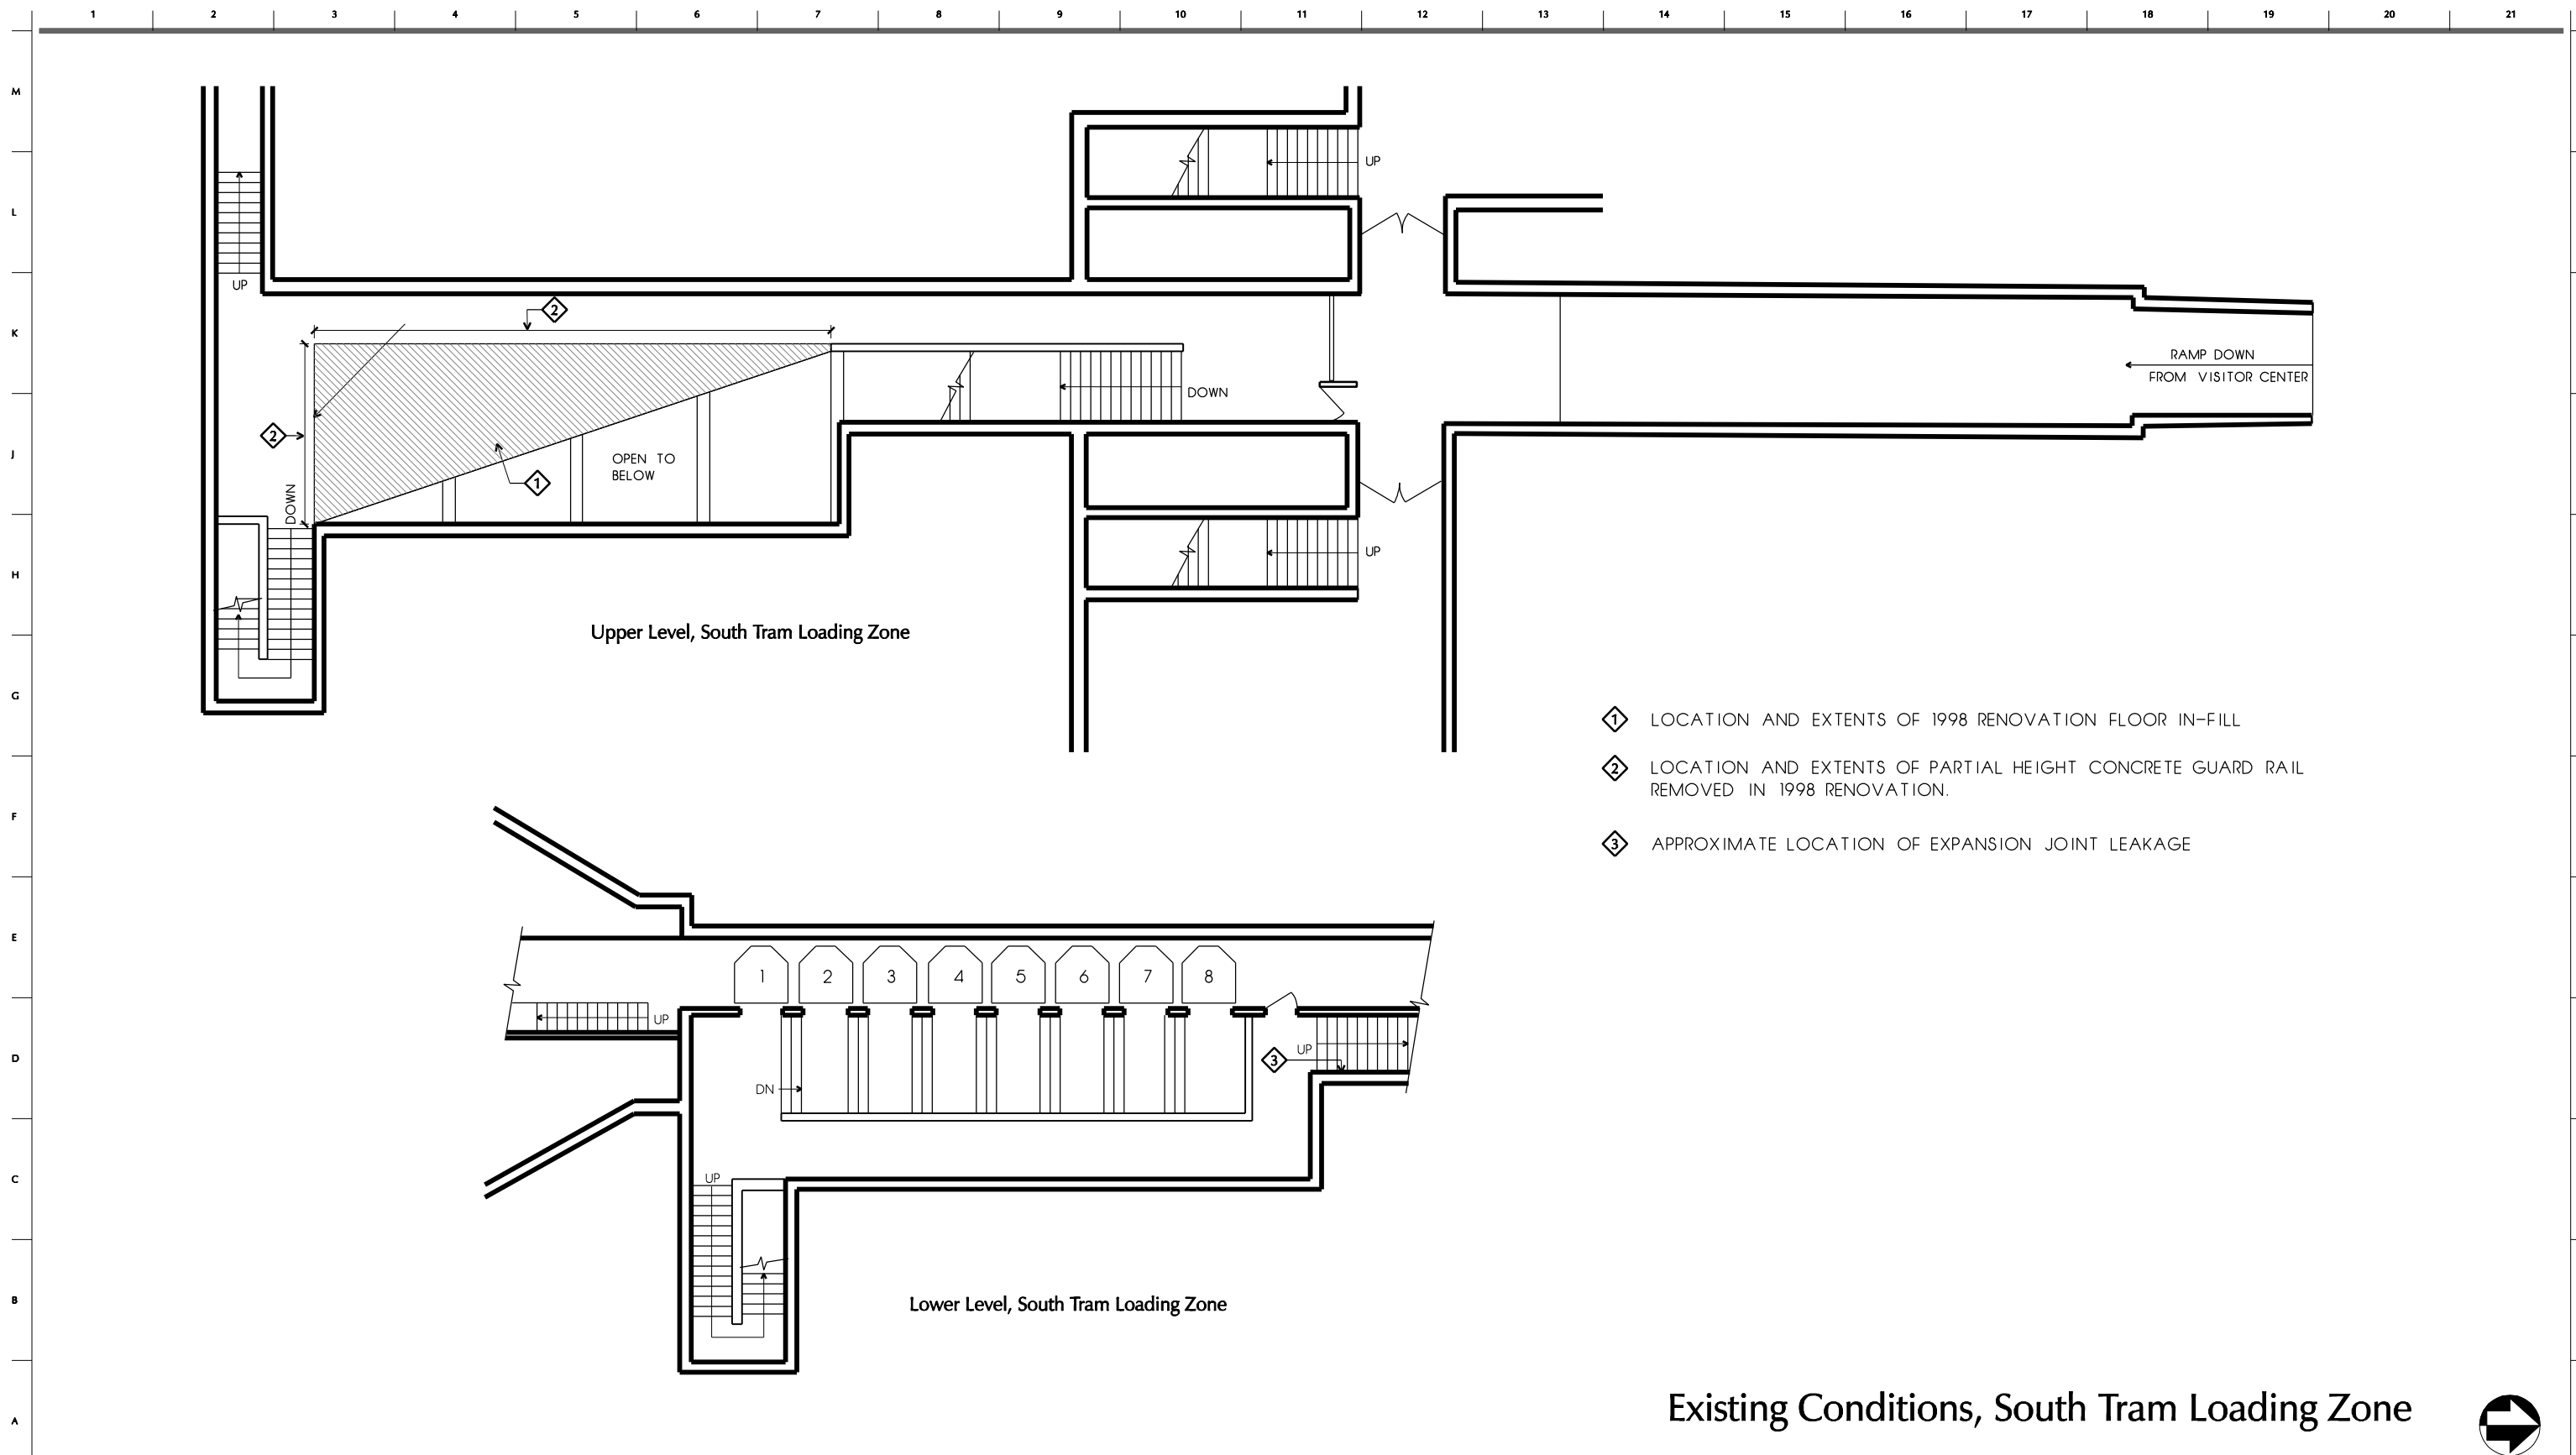
- 1 LOCATION AND EXTENTS OF 1998 RENOVATION FLOOR IN-FILL
- 2 LOCATION AND EXTENTS OF PARTIAL HEIGHT CONCRETE GUARD RAIL REMOVED IN 1998 RENOVATION.
- 3 APPROXIMATE LOCATION OF EXPANSION JOINT LEAKAGE
